Chautauqua Wildfire Mitigation Plan Phase 2 Final Report

SHF Grant #2022-M2-001 Form+Works Project No. 22-040

Chautauqua Wildfire Mitigation Plan

FINAL REPORT August 30, 2023

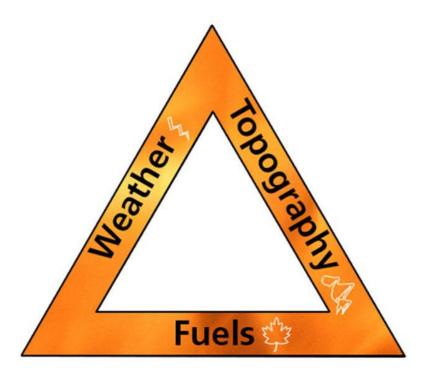
Fuels, weather, and topography are the key factors in wildland fire behavior. As shown in the well-known fire triangle in Figure 1, it is the interaction of these three variables that responders must address when allocating resources to protect life and property.

Figure 1: The Fire Triangle

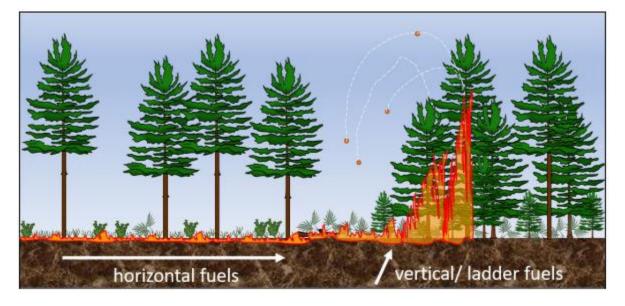
The two primary means of significantly reducing the immediate risk to structure in the WUI are fuels mitigation and creating defensible space. Fuel mitigation involves removing or trimming vegetation to reduce the total volume of material that can burn (the fuel load) while reducing the horizontal and vertical continuity of the fuel to lower the likelihood of the fire being able to spread without interruption, as across a grassy meadow (see (Campbell, 2020)Figure 2). Horizontal fuel continuity is vegetation or other fuel that is continuous, or touching, across the horizontal plane, e.g., there is little or no separation from tree to tree, shrub to shrub, or grasses in a large meadow. Similarly, vertical fuel / ladder fuels continuity is a lack of separation vertically, e.g., grass to shrubs to tree branches to the crowns of the trees would be a typical example.

Figure 2: Diagram Horizontal Fuel and Vertical/Ladder Fuels (Campbell, 2020)

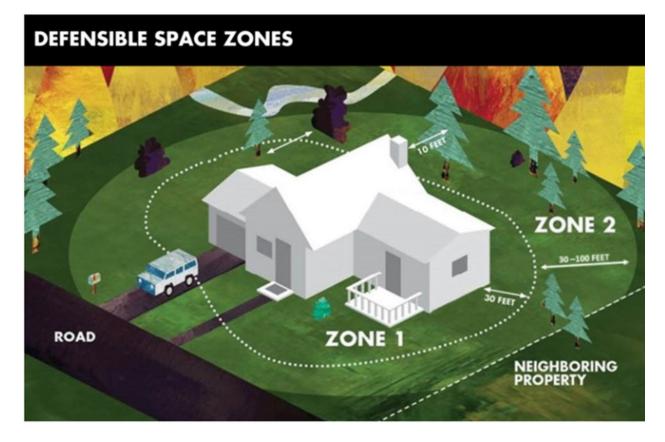
role of building materials on the risk of damage or loss due to fire. Figure 3 and Figure 4 show examples of what are promoted as best practices for establishing defensible space around newly planned residential structures in fire-prone areas prior to construction. These recommendations are good guidance for many single structures in the WUI but not so appropriate for sites with closely spaced buildings and with designated landscape and/or site features that have a historic designation or may be eligible for one. For this reason, consultation between cultural resource specialists, wildfire personnel, and building stewards is likely to result in a compromise when evaluating and determining a fuels mitigation plan and creating defensible space around a historic building or site, rather than the idealized mitigation approaches conveyed in Figure 3 and Figure 4.

Figure 3: Idealized defensible space that is recommended around a single residential structure. This approach is often not feasible for cultural resource sites due to proximity of other structures, heritage trees, or other features that are significant to the cultural landscape.

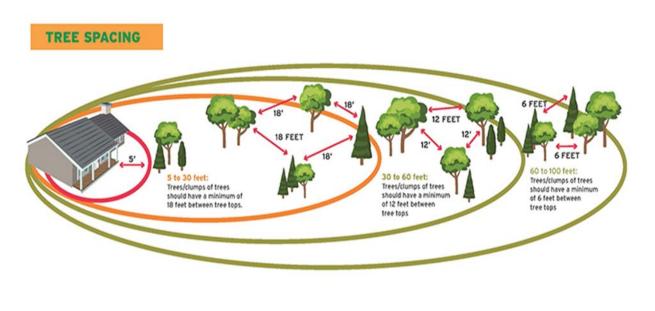
Figure 4: Defensible space as recommended by removing or trimming vegetation to eliminate horizontal and vertical fuel continuity to reduce the risk of the fire spreading and making fire operations more challenging and less safe. As is the case for Figure 3, this approach is often not feasible for cultural resource sites due to proximity of other structures, heritage tress, or other features that are significant to the cultural landscape. (Wildfire Mitigation and Preparedness, 2023)

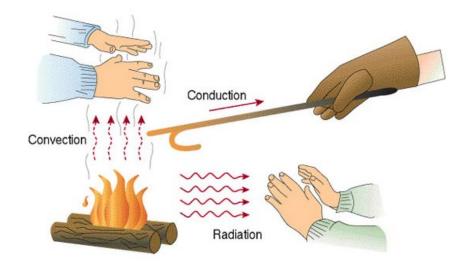
Heat transfer occurs through convection, radiation, or conduction. Convection is the movement of hot air due to heating of the air molecules. Convection is the primary means of fire spread by pre-heating fuels in advance of the fire, including the upper crowns of trees. Radiation is the movement of heat energy as waves pass through the air. The heat is transferred when the wave reaches a physical object that conducts heat. Radiant heat from a wildfire can ignite combustible materials inside a structure from several hundred feet away in extreme events. Conduction occurs when heat is transferred from molecule to molecule through direct contact, such as when one touches a hot skillet, see Figure 5.

Figure 5: Diagram of Convection, Conduction, and Radiation Heat (Shirley, 2015)

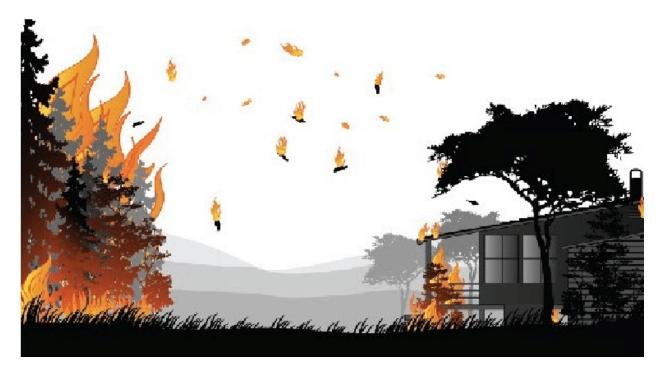
Firebrands, or embers, are airborne burning materials that can cause ignition when they come in contact with unburned fuel. Embers can be from vegetation (pinecones, sticks, leaves, etc.), structures (roofing, siding, even roof sections, etc.), or other burning materials. Wind can carry the embers long distances, farther than convection or radiation can transfer heat for combustion, and upon landing can ignite vegetation or get into openings (e.g., uncovered vents) in structures and start fires on the interior before the flames ever reach the structure, see Figure 6. While embers have always been a concern during wildfires, the wind speeds and gusts recorded in relatively recent fires can travel, or spot, well over a mile in extreme wind events where gusts exceed 60 to 80 mph. Most structures lost to wildfire are the result of embers causing ignition of the structure itself, or traveling from ignition of the landscape or elements nearby, thus reinforcing the need for fuels reduction and mitigation.

Figure 6: Illustration of Firebrand / Embers Traveling from Fire to Structure (Walls, 2023)

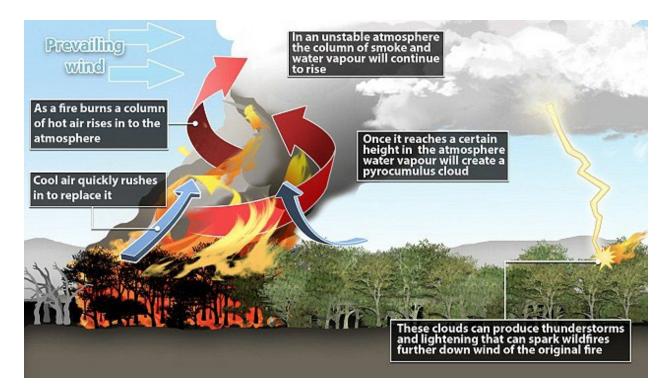
Figure 7: Diagram of a convective column (Pedrógão Grande Fire Timeline, 2018)

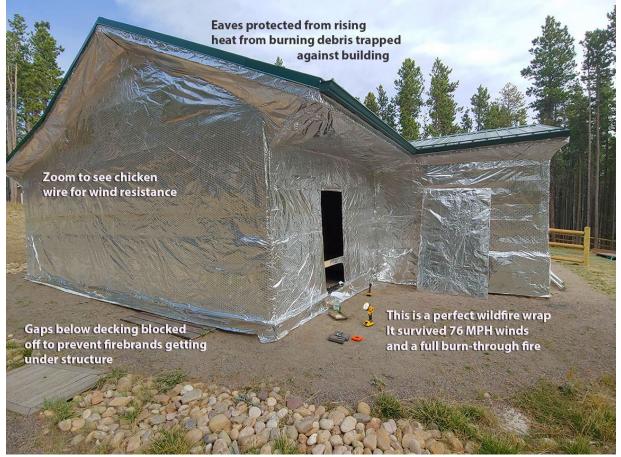
Conclusion: This is a temporary protective measure that has a relatively high level of reversibility with regards to the SOI standard, i.e., holes from chicken wire with staple method of install can be filled, although installing the wrap can use thousands of staples that can damage weathered wood that is friable. It has been utilized by the Forest Service, National Park Service, and the Bureau of Land Management, to name a few, and is proven to protect critical structures from embers, radiant heat and direct flames. There are a significant amount of case studies and testing to back-up this product's performance (Firezat, 2023).

Figure 10: Firezat installation with chicken wire and staples. Building has an existing metal roof eliminating the need to wrap the roof. Image credit: firezat.com, accessed March 21, 2023

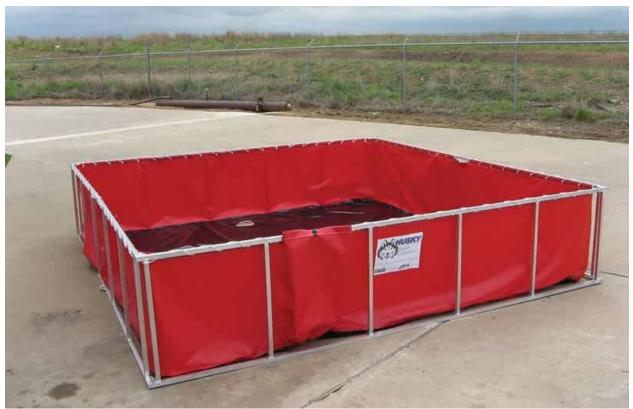
In addition to the sprinklers and portable fire pump, collapsible water storage tanks may be an essential component for a successful sprinkler operation. Tanks can be stored when not in use and expanded and filled with water prior to arrival of the fire. The water supply can be domestic supply from buildings, fire hydrants (although hydrants not intended for use by the public) and can be refilled by water tenders during fire operations. They are often used during fire operations to refill fire apparatus that are too far from hydrants or other water sources to maintain continuity in the firefighting operation due to long turn-around times. Tanks can hold a few hundred gallons up to several thousand gallons of water. There is a liability of having an open water tank on site due to the risk of drowning if someone (a child) should inadvertently have access to the tank. There are various manufacturers and types of collapsible water storage tanks, a couple of manufacturers include: Feld Fire (Portable Water Tank - Steel Frame, 2023); Husky Portable Containment (Husky Portable Folding Frame Water Tanks, 2023) and Fol-Da-Tank (Fol-Da-Tank Collapsible Fire Department Frameless Water Tank, 2023). Capacity (sizes) vary per manufacturer and product but range from 250 to 10,000 gallons. Similarly costs vary from \$700 to \$8,000. Additional consideration would be needed to determine the correct sizing and product to purchase.

Figure 11: Image of a Husky Portable Water Tank (Husky Portable Folding Frame Water Tanks, 2023)

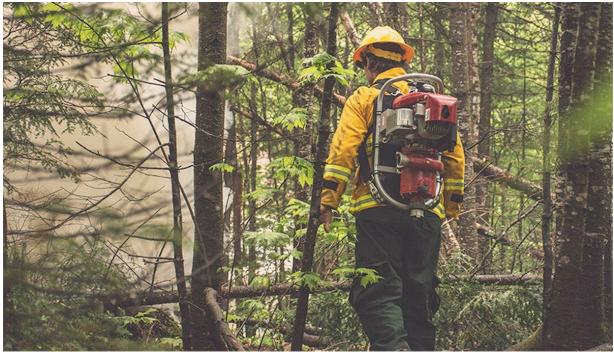
The system can be connected in series with other pumps to move water over long distances, maintaining its volume. The MK3-U unit has a maximum pressure of 380 pounds per square inch, a maximum flow of 98 gallons per minute, and a maximum head of 878 feet (meaning the maximum height a pump can raise a fluid up)

Figure 12: Waterax MARK-3 Website Photo, Accessed May 23, 2023

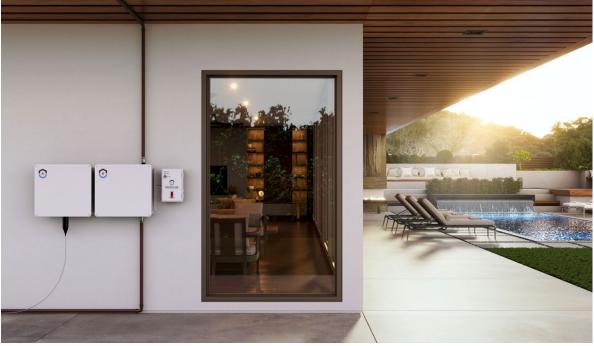
The system offers manual and remote activation options. A typical system will use the building's primary water source first; if there is a drop in pressure, the system will automatically switch to a secondary water source such as a pool, tank or well. The system is designed to mitigate the risk of ember ignition during a wildfire.

Figure 14: Defense System 2 Website Photo Control System and Surface-Run Piping, Accessed May 23, 2023

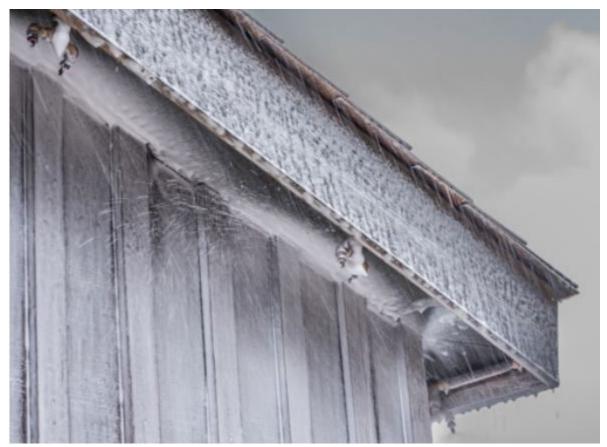
Figure 15: Defense System 2 Website Photo Soffit Sprinklers and Foam, Accessed May 23, 2023

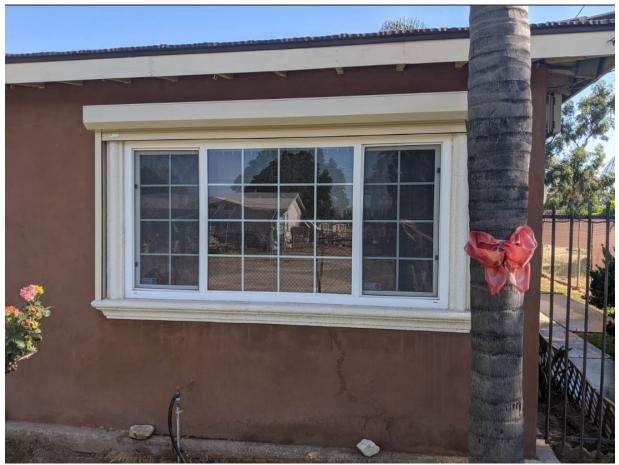
These exterior rolling shutters are installed over a building's windows and doors, but do not have an official fire-rating. The shutters provide a physical barrier to reduce radiant and convective heat from entering the building and igniting objects. They also offer a barrier to flying debris or falling objects that might break through windows and doors. The shutters can be operated manually by a push button or on an automated system with an electric motor and hard-wired switch.

Figure 16: Enviroblind shutter in open position. Image credit: enviroblind.com, accessed March 21, 2023

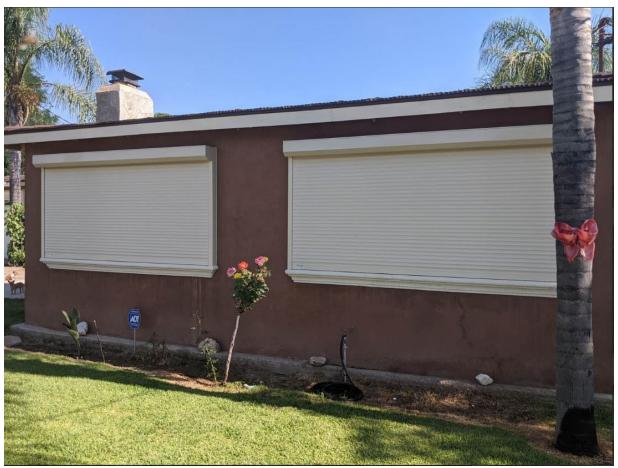
Figure 17: Enviroblind shutter in closed position. Image credit: enviroblind.com, accessed March 21, 2023

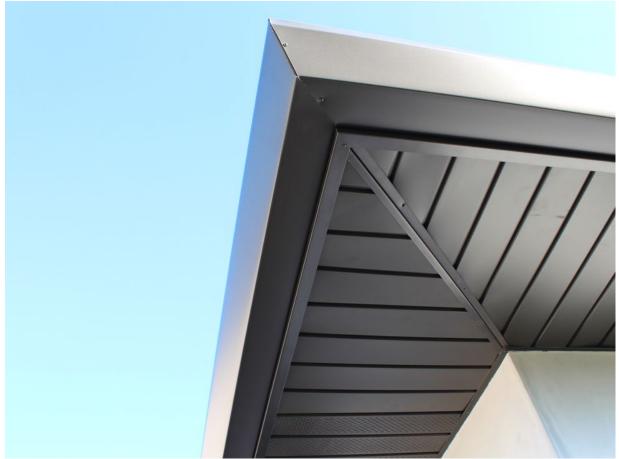
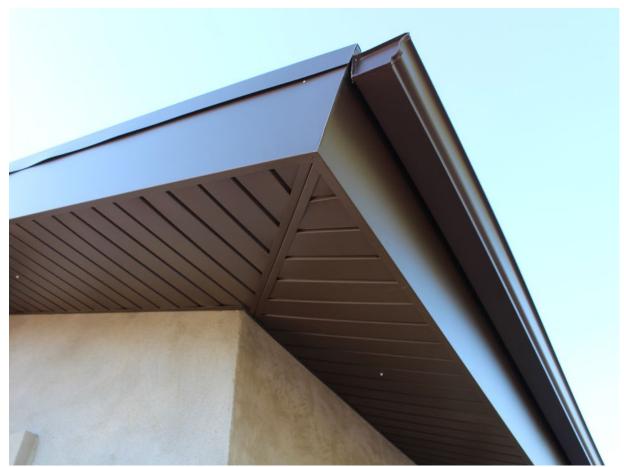
One potential solution to respond to the ignition risk of wood soffits and trims is to enclose them with sheet metal. There are companies that do this sort of treatment, made more common in California due to their wildfires. A Plus Gutter Systems of Los Angeles and Orange County (A Plus Gutter Systems, Undated) has several photos of work they have completed, see Figure 15 and Figure 16.

Figure 19: A Plus Gutter Systems of Los Angeles and Orange County, Photo of soffit and fascia retrofitting with sheet metal, Accessed May 17, 2023

Figure 20: A Plus Gutter Systems of Los Angeles and Orange County, Photo of soffit and fascia retrofitting with sheet metal, Accessed May 17, 2023

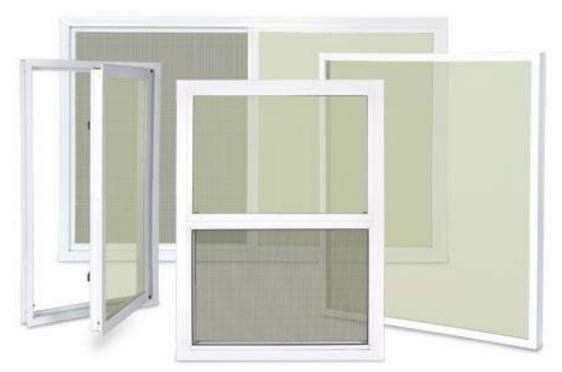
This is a manufactured fire-rated steel window. The rolled steel sections have welded corners for strength and durability. The window frames have been listed by Underwriters Laboratories. Styles of windows include horizontal slider, single hung, fixed lite, awning, and casement. UL rated factory glazing options include clear ceramic 1 hour rated glass or ¼ inch wire glass with a 45-minute rating. These rated glazing types can be combined with Low-E glazing (to reduce UV and infrared light) in an insulated glass unit (IGU). Heat activated fusible links are standard on all operating windows which close the windows in the presence of fire. Horizontal sliding windows may also be equipped with a resettable device which may be activated by a fire or smoke alarm, computer, or another electrical signal.

Figure 22: Fyre-Tec Fire Rated Window Styles. Image credit: fyre-tec.com, accessed March 21, 2023

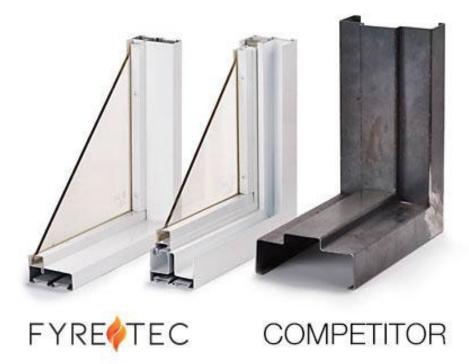
Figure 23: Fyre-Tec Fire Rated Window Sections Compared to Typical Rated Window Frame Construction. Image credit: fyre-tec.com, accessed March 21, 2023

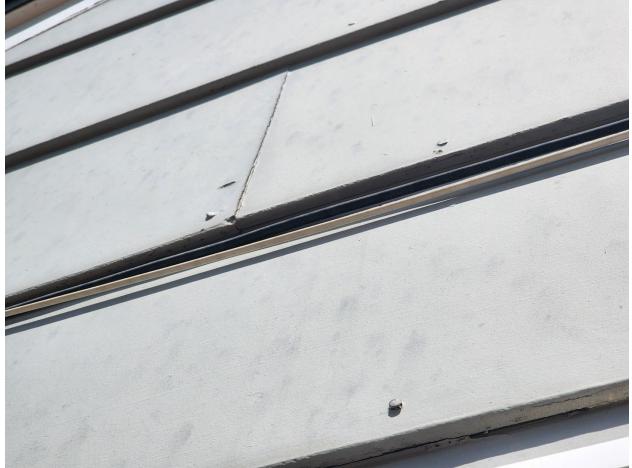
Figure 34: West Wall of 1957 Ranch in Colorado, Nails Visibly Working Their Way Out of Fiber Cement Siding (Lord, 2023)

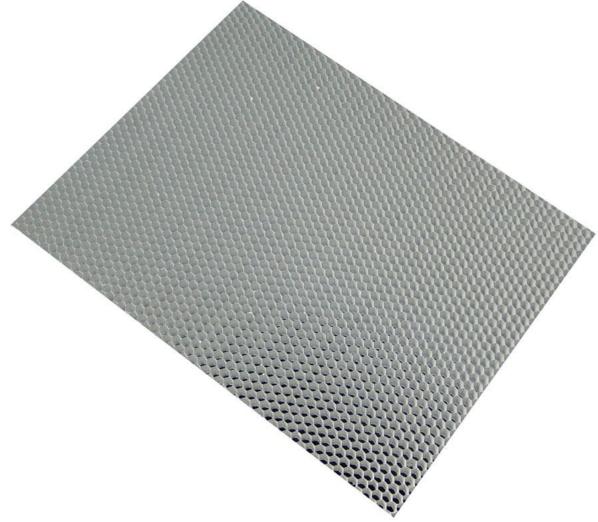
Figure 40: Vulcan Vent Honeycomb Matrix, Accessed May 22, 2023

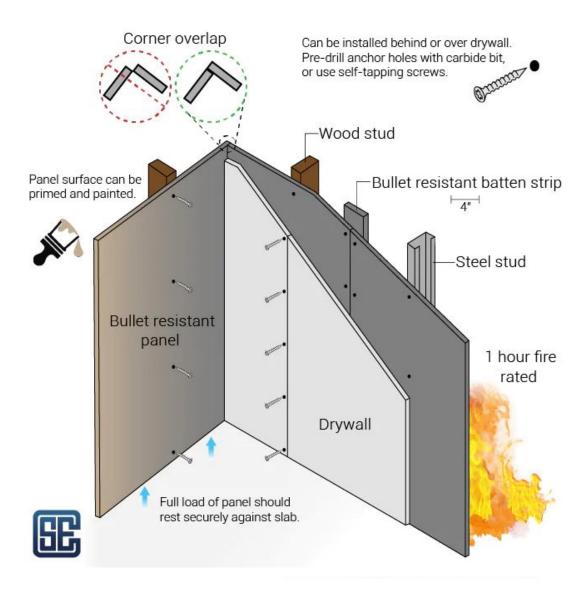
Figure 45: Armortex Installation Diagram, Accessed May 23, 2023

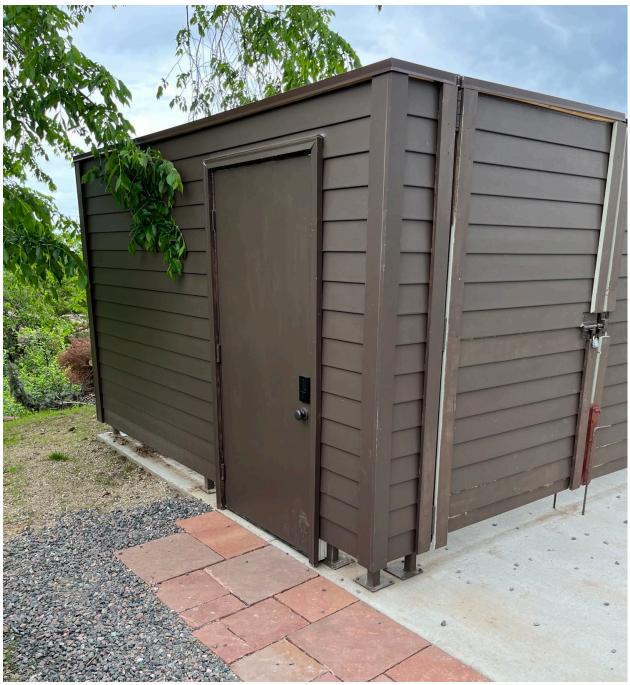
Figure 46: Fiber Cement Siding approved at new Chautauqua Trash Enclosure

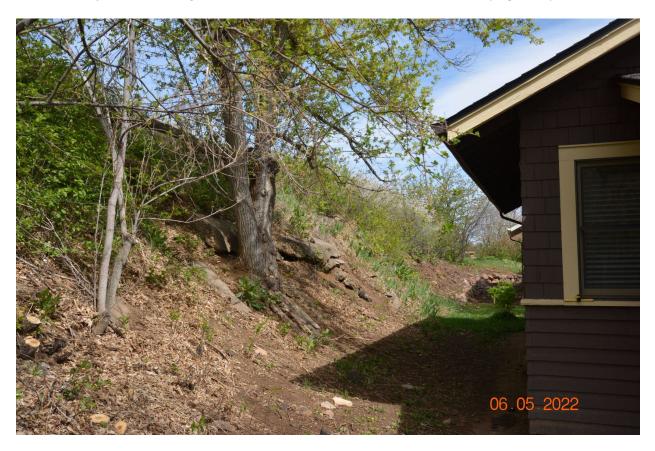
Figure 2. Western boundary where fuels mitigation has been conducted. Note there has been a reduction in fuel load and thinning of some of the horizontal and vertical continuity. However, enough vegetation remains, mostly shrubs, to allow for spread of a fire from the west onto Chautauqua property.

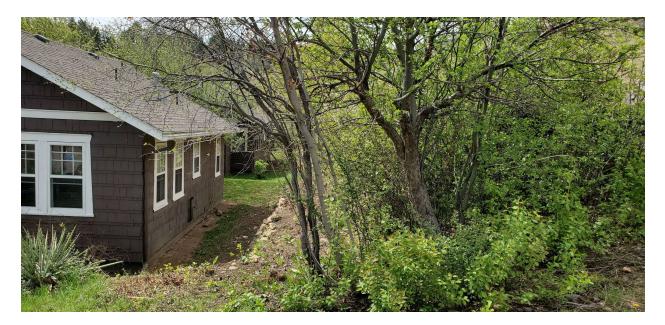
Figure 3. Western boundary where fuels mitigation is yet to be conducted. Note the horizontal and vertical continuity of the vegetation which would allow for a fire to easily spread.

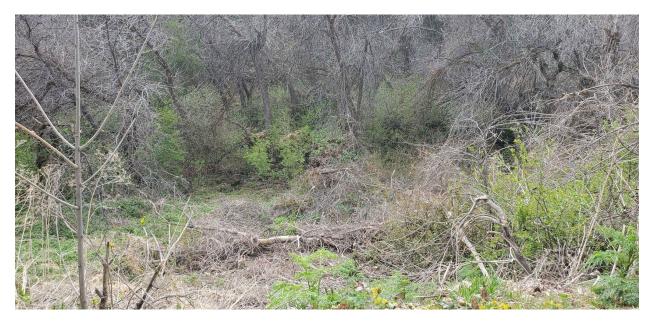
Figure 4. OSMP property on eastern boundary where fuel mitigation work was done. However, this area would benefit from further removal of vegetation to reduce horizontal and vertical continuity as well as fuel load. Defensible space around a structure to reduce the likelihood of significant damage or loss of the structure is a concept that has been promoted for decades, along with an understanding of the role of building materials on the risk of damage or loss due to fire. **Figures 5 and 6** show examples of what are promoted as best practices for establishing defensible space around residential structures in fire-prone areas. These recommendations are good guidance for many residential structures or other buildings in the WUI but not so appropriate for Chautauqua. The designation as a National Historic Landmark needs to be balanced with standard recommended mitigation practices. As is seen in **Figure 8**, it is not possible to achieve the recommended defensible space between buildings at Chautauqua because of the close spacing of structures.

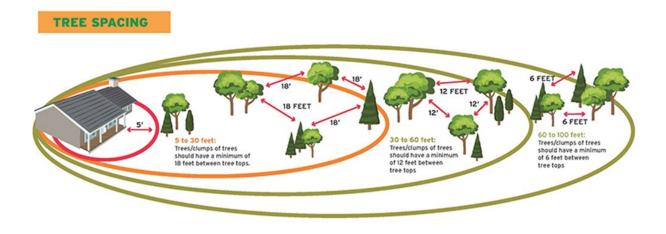
Figure 6. Defensible space as recommended by removing or trimming vegetation to eliminate horizontal and vertical fuel continuity to reduce the risk of the fire spreading and making fire operations more challenging and less safe.

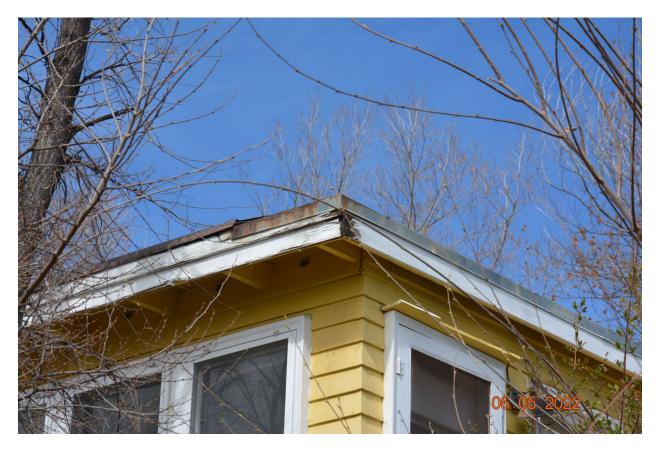
Figure 7. Deteriorated fascia board that provides an entry for wind-blown embers can result in an ignition on the interior of the structure.

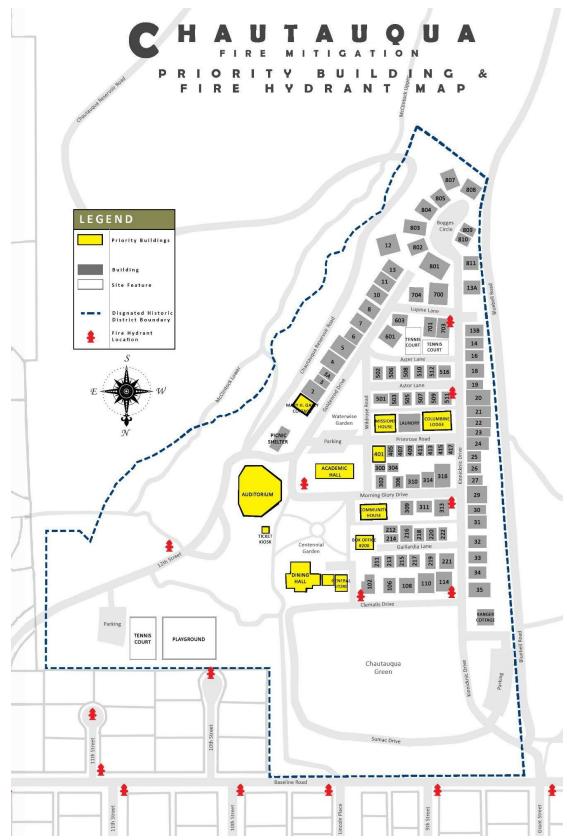
Figure 10. Chautauqua Priority Buildings and Fire Hydrants Map

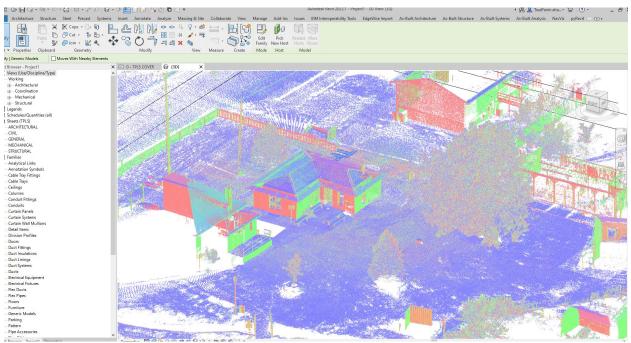
Figure 12. A point cloud file from a LiDar scan imported into Revit (an AutoDesk program utilized to create architectural and engineering 3D models and drawings of buildings).

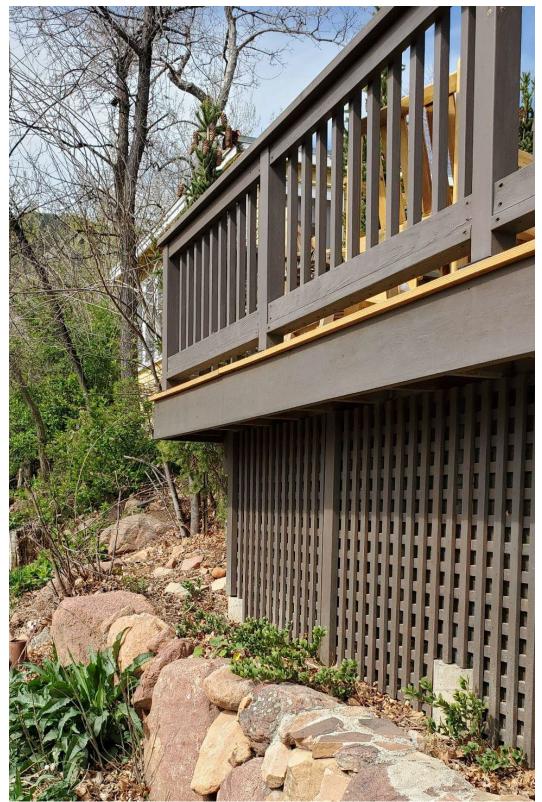
Figure 13. Mary H. Galey Cottage deck enclosure. The enclosure uses fire-retardanttreated wood and metal mesh to reduce combustibility and the likelihood of large embers causing ignition under the deck.
